# **BRANZ** Technical Opinion

## **ST 11332-TO**[2020]

### **PULLOUT STRENGTHS OF THREE STEEL AND TUBE WEDGENUTS, ATTACHED TO THREE COMFLOR METAL DECKING PROFILES**

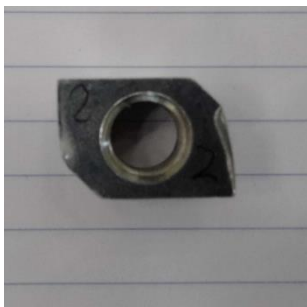
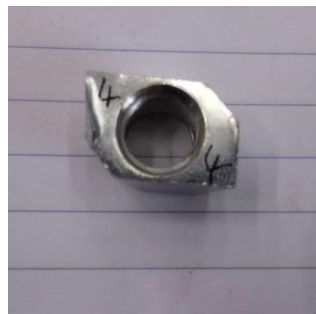
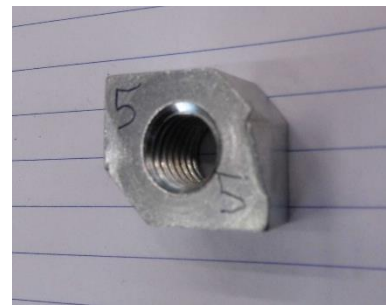
**Figure 4. Wedgenuts as tested, with packet markings, and measured outside dimensions**

The wedgenuts as tested are shown in Figure 4. Each nut had a thickness of 10 mm, and an M10 threaded hole. For testing each nut was fitted with a M10 threaded rod with a fender washer and lock nut. A complete assembly can be seen in Figure 5.

ComFlor 60.  
M10WM(65).  
21mm x 14mm

ComFlor 80.  
M10WN(80).  
18mm x 12mm

ComFlor SR. 22mm x 18mm

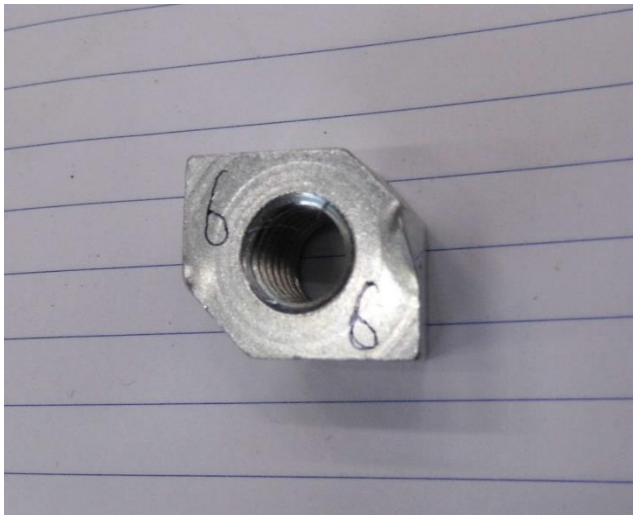
**Figure 8. Wedgenut after test.**

Some wedgenuts were also chipped at a corner on withdrawal from the dovetail, see Figure 8.
