Fire Resistance Test in  
Accordance with  
AS 1530.4: 2014, on a  
Loadbearing Composite Floor  
Assembly

381193

**ComFlor Building Systems**  
Steel & Tube Stainless (ComFlor)  
30, Business Parade North  
Highbrook  
Manukau  
Auckland  
New Zealand

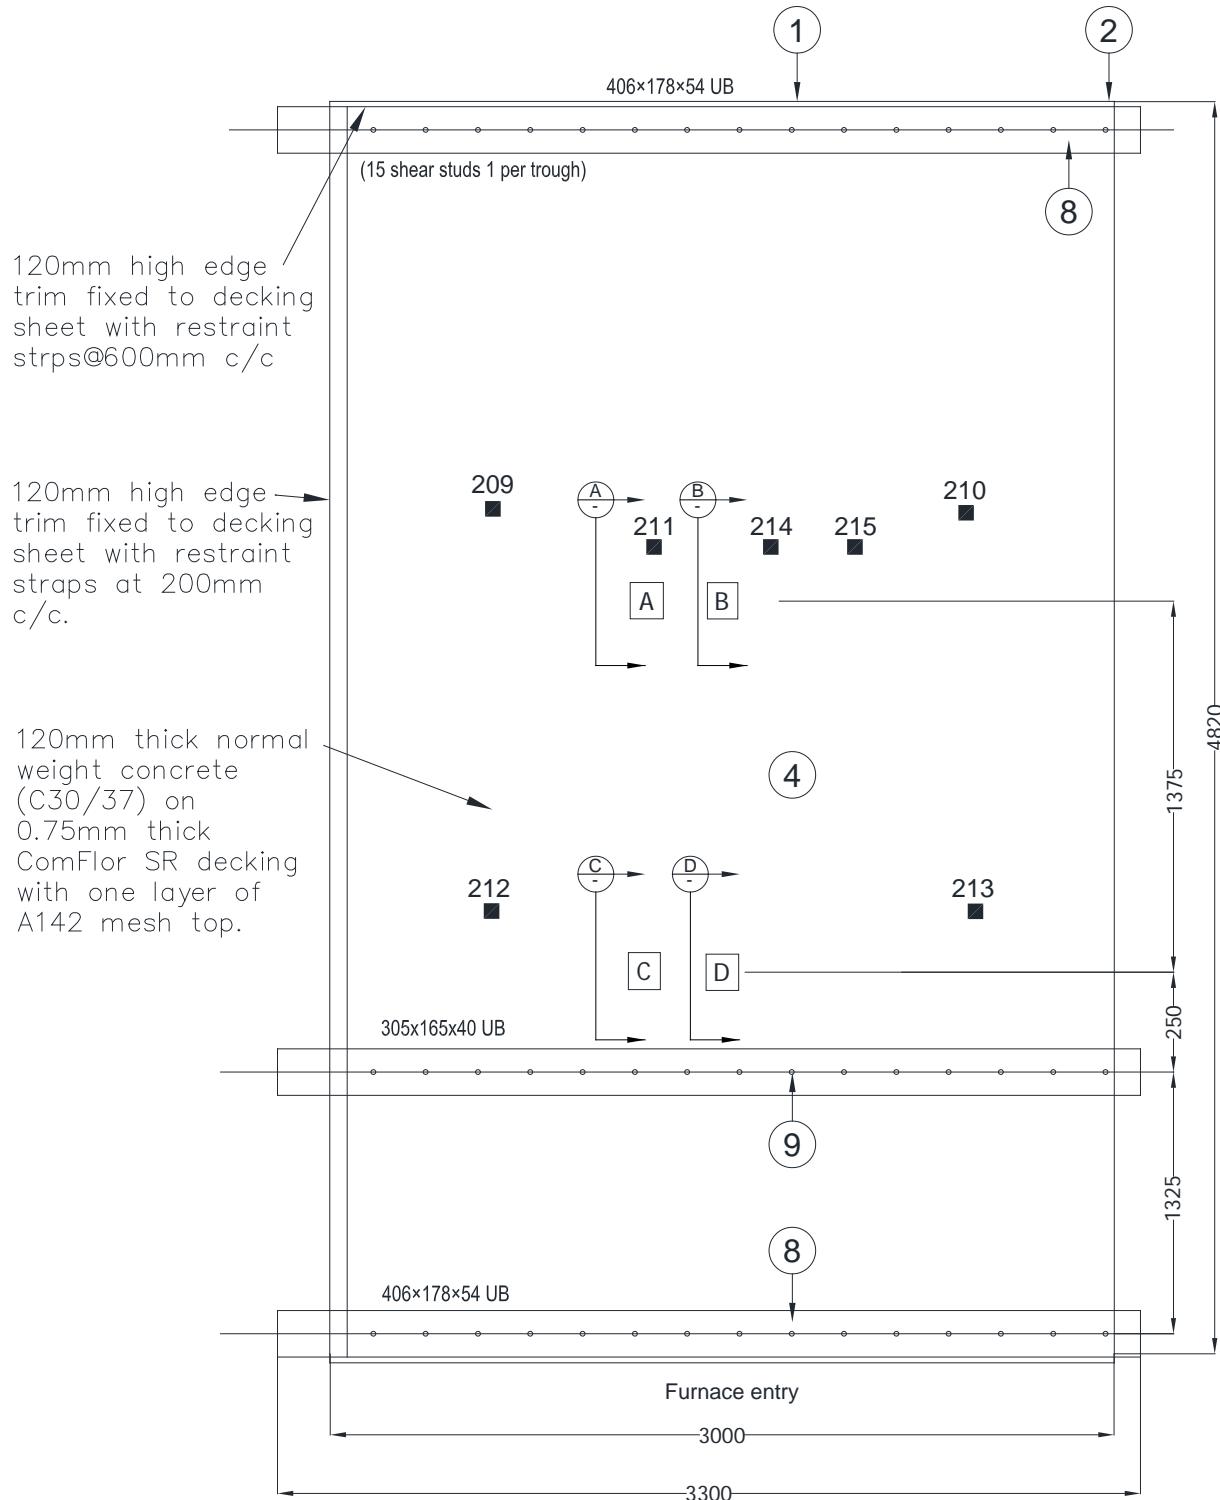
Figure 1- General Elevation of Test Construction

Plan view on test specimen

■ Denotes thermocouple layout

(Refer to Figures 1 & 7)  
(All values are nominal unless stated otherwise)  
(All other details are as stated by the sponsor)

The locations and reference numbers of the various unexposed surface and internal thermocouples are shown in Figures 1, 4, 5 and 6.
<b>Roving Thermocouple</b>	A roving thermocouple was available to measure temperatures on the unexposed surface of the specimen at any position, which might appear to be hotter than the temperatures indicated by the fixed thermocouples.
<b>Loadbearing Capacity Criteria</b>	A linear deflection transducer was provided at the geometric centre of the unexposed surface of the loaded area to record the deflection of the floor.
<b>Integrity criteria</b>	Cotton pads and gap gauges were available to evaluate the integrity of the specimen.
<b>Furnace Pressure</b>	The pressure differential relative to the laboratory atmosphere, at a position 100 mm below the underside of the floor assembly, was calculated to be 20 ( $\pm 2$ ) Pa.

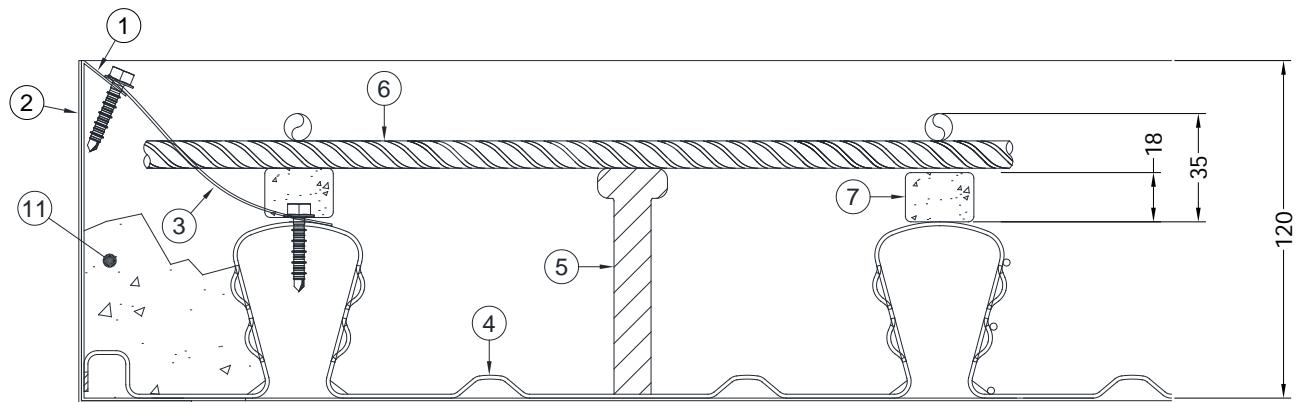
Figure 3 – Cross Section Details Through Floor Construction

Cross section through floor  
transversal edge

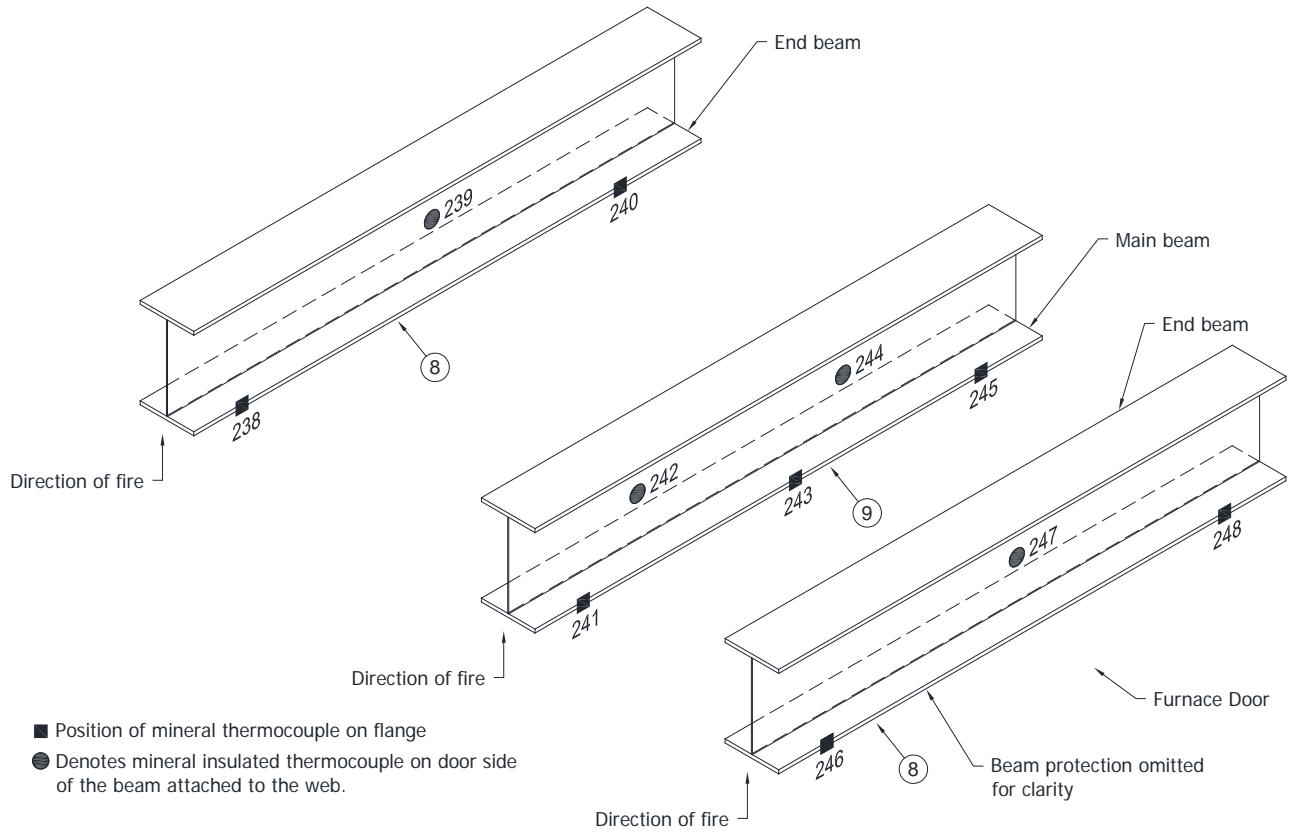
Figure 6 – Thermocouple Layout Details

Isometric view on beams showing  
thermocouple layout

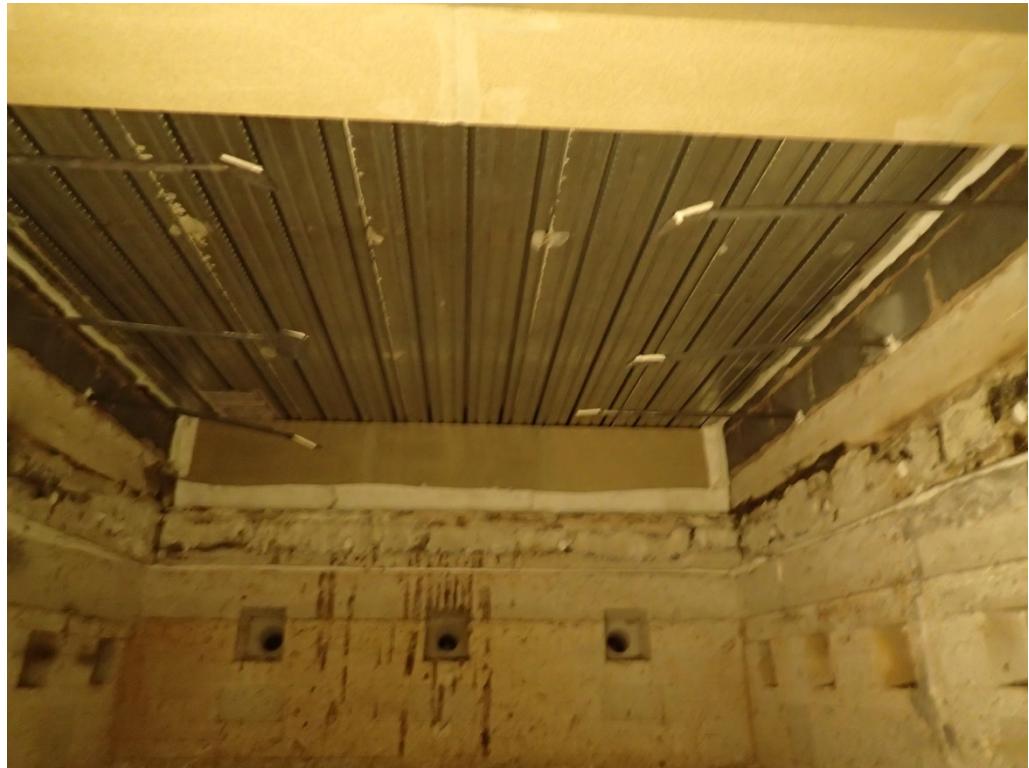
The exposed face  
of the test  
specimen prior to  
testing

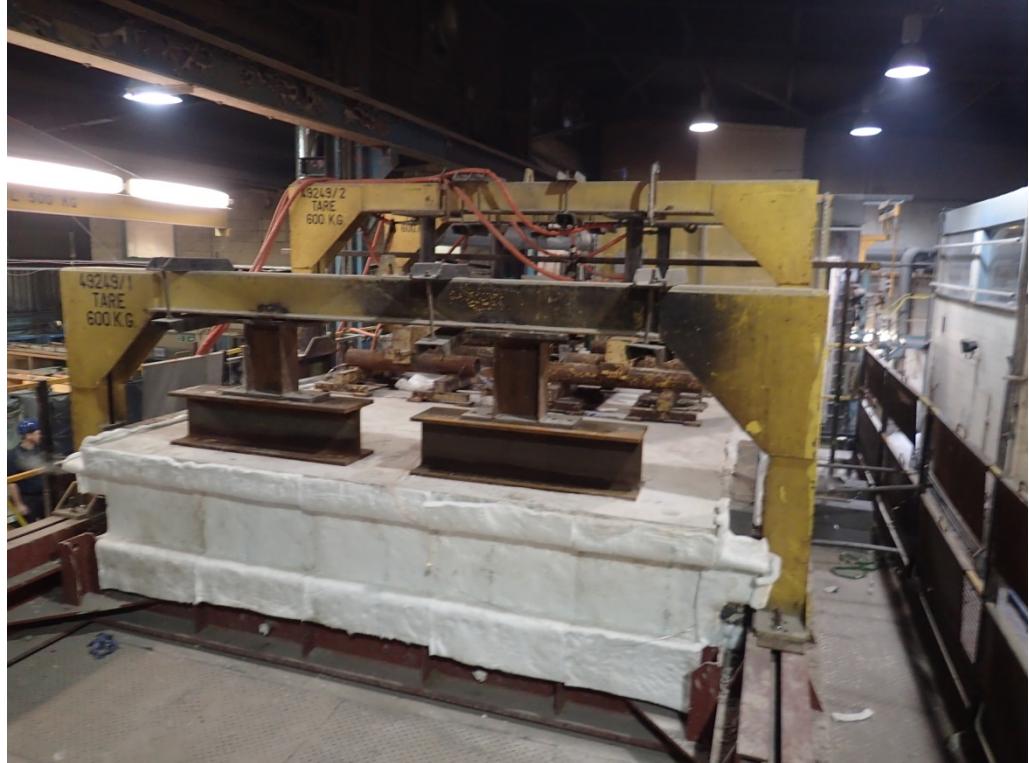
The unexposed  
face of the test  
specimen prior to  
the start of the  
test

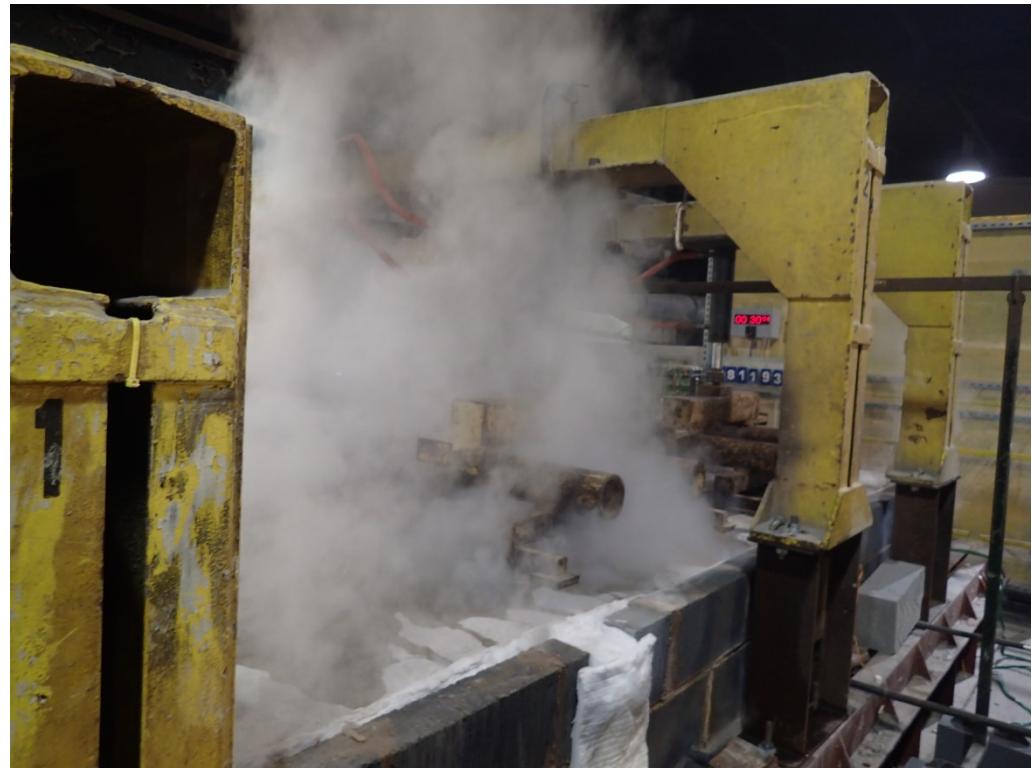
The unexposed face of the test specimen after a test duration of 30 minutes

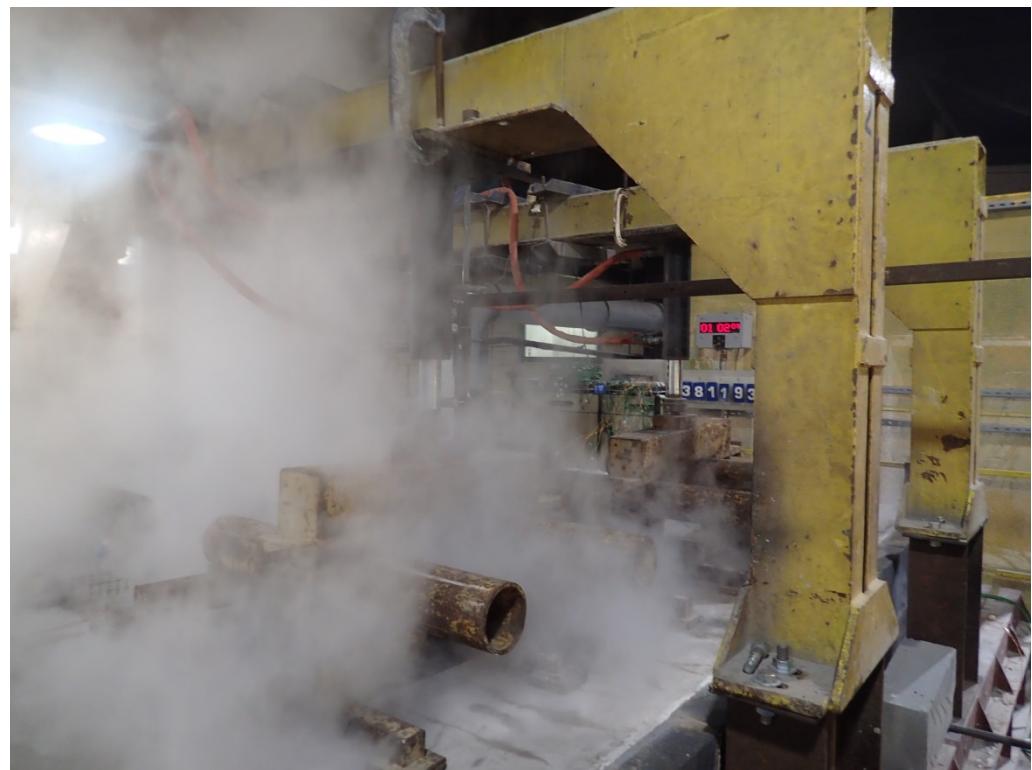
The unexposed face of the test specimen after a test duration of 62 minutes

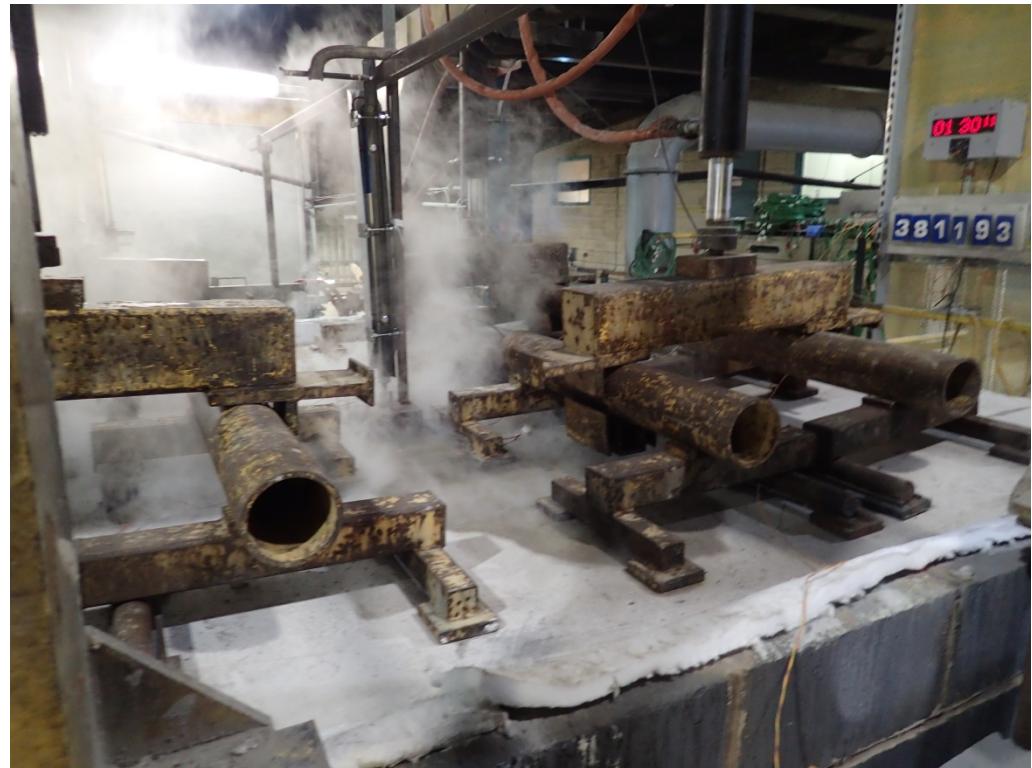
The unexposed face of the test specimen after a test duration of 90 minutes

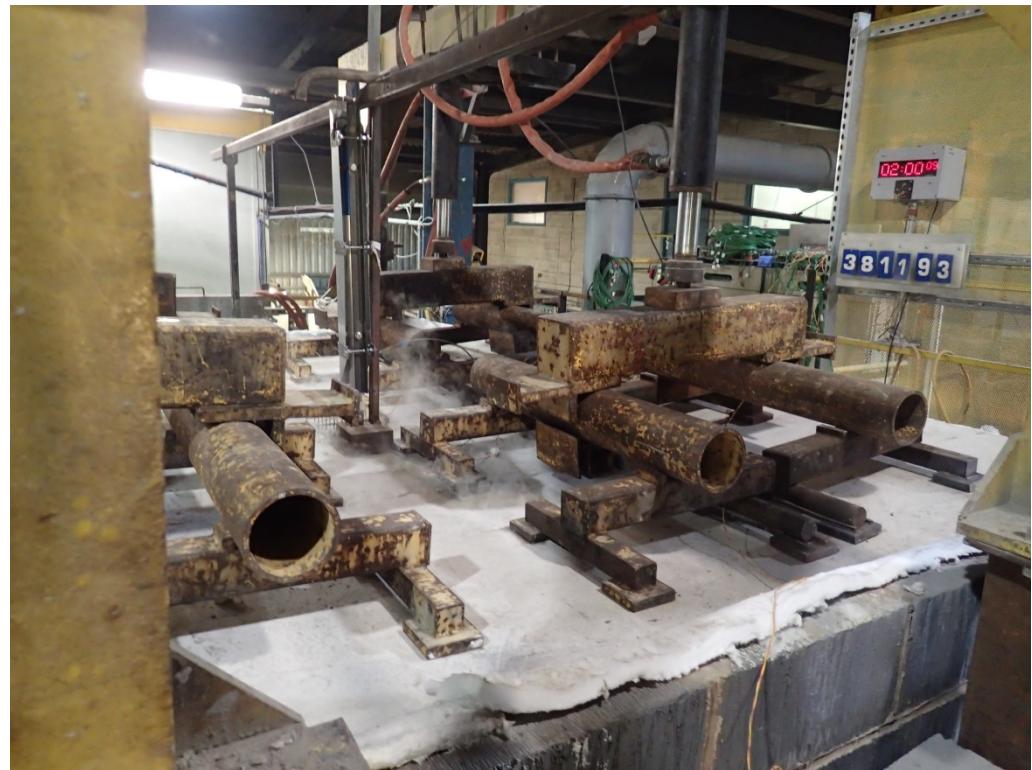
The unexposed face of the test specimen after a test duration of 120 minutes

<b>95      00</b>	The steam release is decreasing slightly.
<b>110     00</b>	A crack, several millimetres wide and deep, has formed in the concrete over the central steel beam.
<b>120     00</b>	The specimen floor is maintaining its loadbearing capacity, integrity and insulation.
<b>125     00</b>	Steam release has virtually ceased.
<b>140     00</b>	There are no visible significant changes to the unexposed and exposed faces of the floor assembly.
<b>180     00</b>	The specimen floor is maintaining its loadbearing capacity, integrity and insulation.  At the request of the client the test is discontinued.

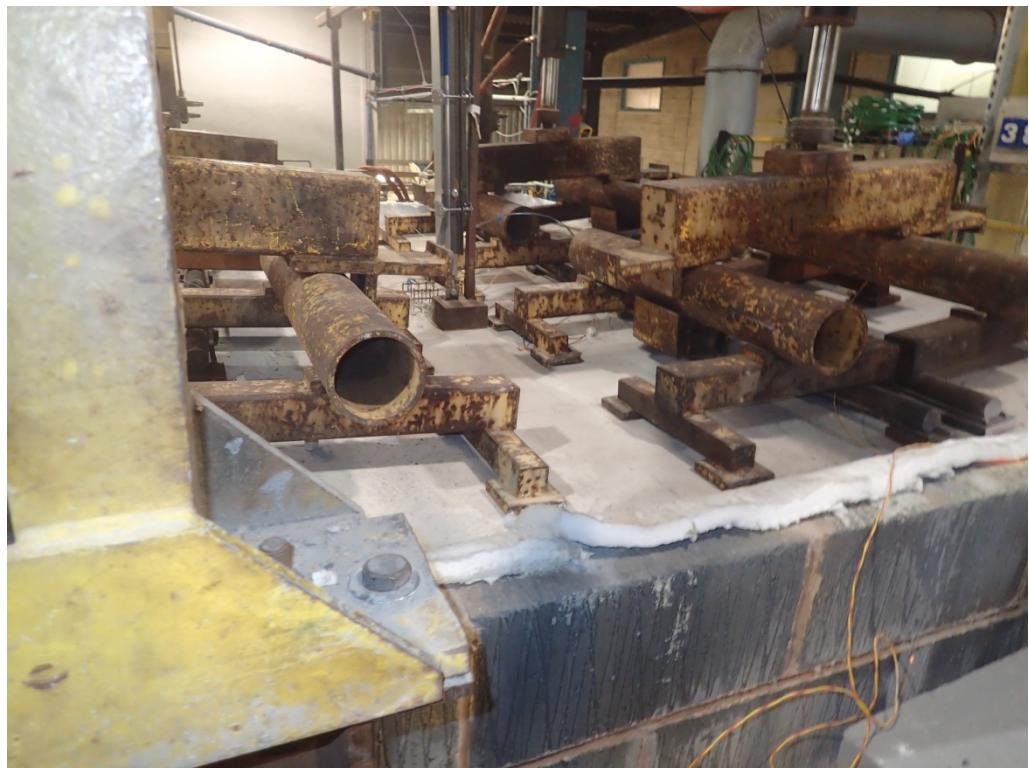
The unexposed  
face of the test  
specimen after a  
test duration of  
180 minutes

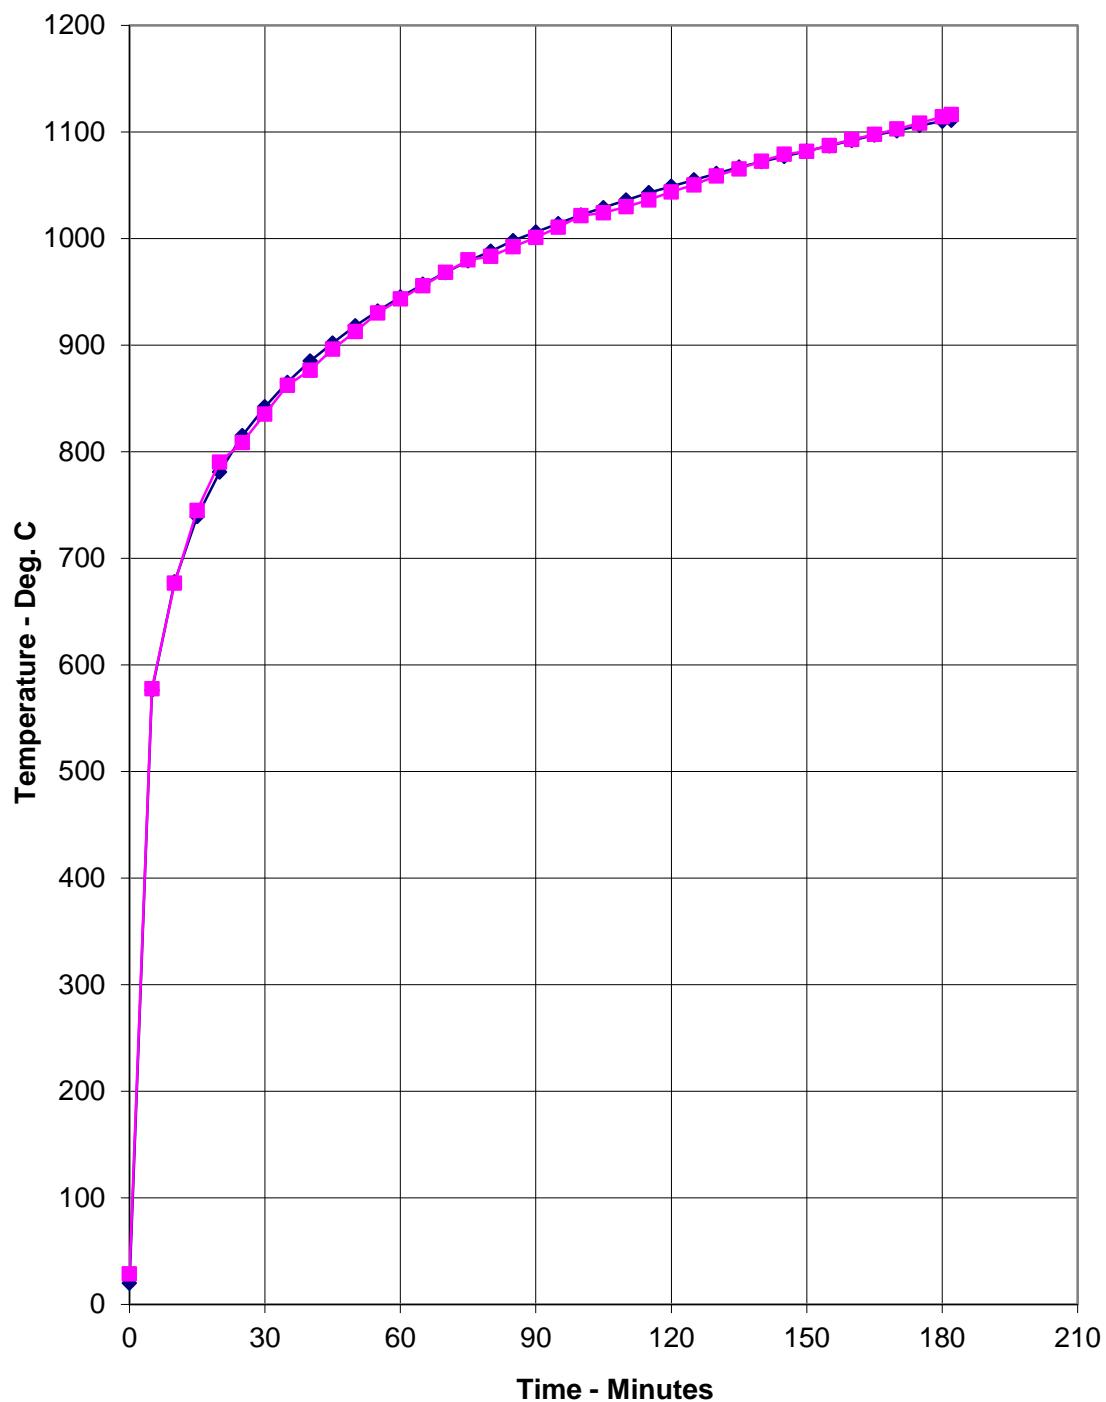
**Graph Showing Mean Furnace Temperature, Together with the Temperature/Time Relationship Specified in the Standard**

Time Minutes	Specified Furnace Temperature Deg. C	Actual Furnace Temperature Deg. C
0	20	29
5	576	578
10	678	677
15	739	745
20	781	790
25	815	809
30	842	835
35	865	862
40	885	877
45	902	896
50	918	913
55	932	930
60	945	943
65	957	956
70	968	968
75	979	980
80	988	983
85	998	992
90	1006	1001
95	1014	1011
100	1022	1021
105	1029	1024
110	1036	1030
115	1043	1036
120	1049	1044
125	1055	1050
130	1061	1059
135	1067	1065
140	1072	1073
145	1077	1079
150	1082	1082
155	1087	1087
160	1092	1093
165	1097	1098
170	1101	1103
175	1106	1108
180	1110	1114

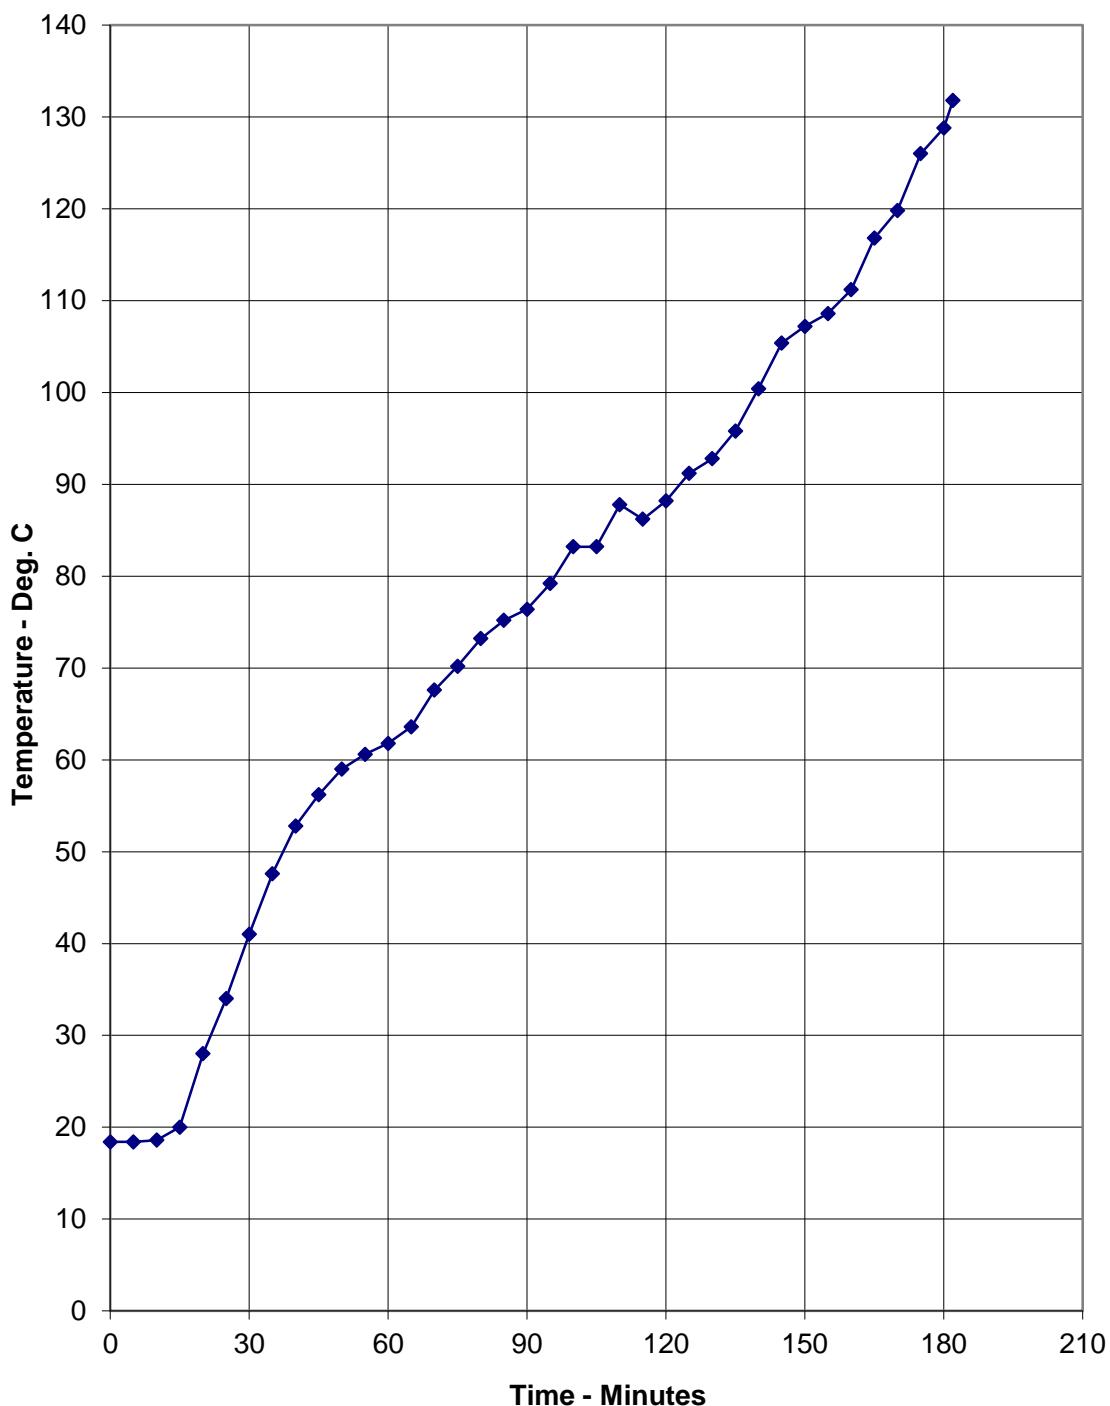
**Graph showing Mean Temperatures Recorded on the Unexposed Surface of the Specimen**

Time Minutes	T/C Number 209 Deg. C	T/C Number 210 Deg. C	T/C Number 211 Deg. C	T/C Number 212 Deg. C	T/C Number 213 Deg. C	Mean Temp Deg. C
0	18	18	18	19	19	18
5	18	18	18	19	19	18
10	18	18	18	20	19	19
15	19	19	19	24	19	20
20	22	21	21	55	21	28
25	26	24	24	71	25	34
30	31	29	28	76	41	41
35	35	35	33	84	51	48
40	39	41	37	90	57	53
45	43	46	42	91	59	56
50	46	50	47	92	60	59
55	47	53	50	92	61	61
60	44	56	54	93	62	62
65	45	61	56	93	63	64
70	54	67	58	93	66	68
75	55	73	60	93	70	70
80	60	78	60	93	75	73
85	60	83	61	93	79	75
90	55	86	62	94	85	76
95	61	89	63	94	89	79
100	72	93	64	94	93	83
105	67	96	63	94	96	83
110	80	99	65	95	100	88
115	66	102	66	94	103	86
120	67	105	67	95	107	88
125	74	108	68	95	111	91
130	74	110	70	95	115	93
135	76	113	77	95	118	96
140	78	116	91	95	122	100
145	87	119	99	95	127	105
150	85	122	103	95	131	107
155	80	126	108	95	134	109
160	80	130	112	95	139	111
165	93	136	117	95	143	117
170	93	142	122	95	147	120
175	105	149	127	95	154	126

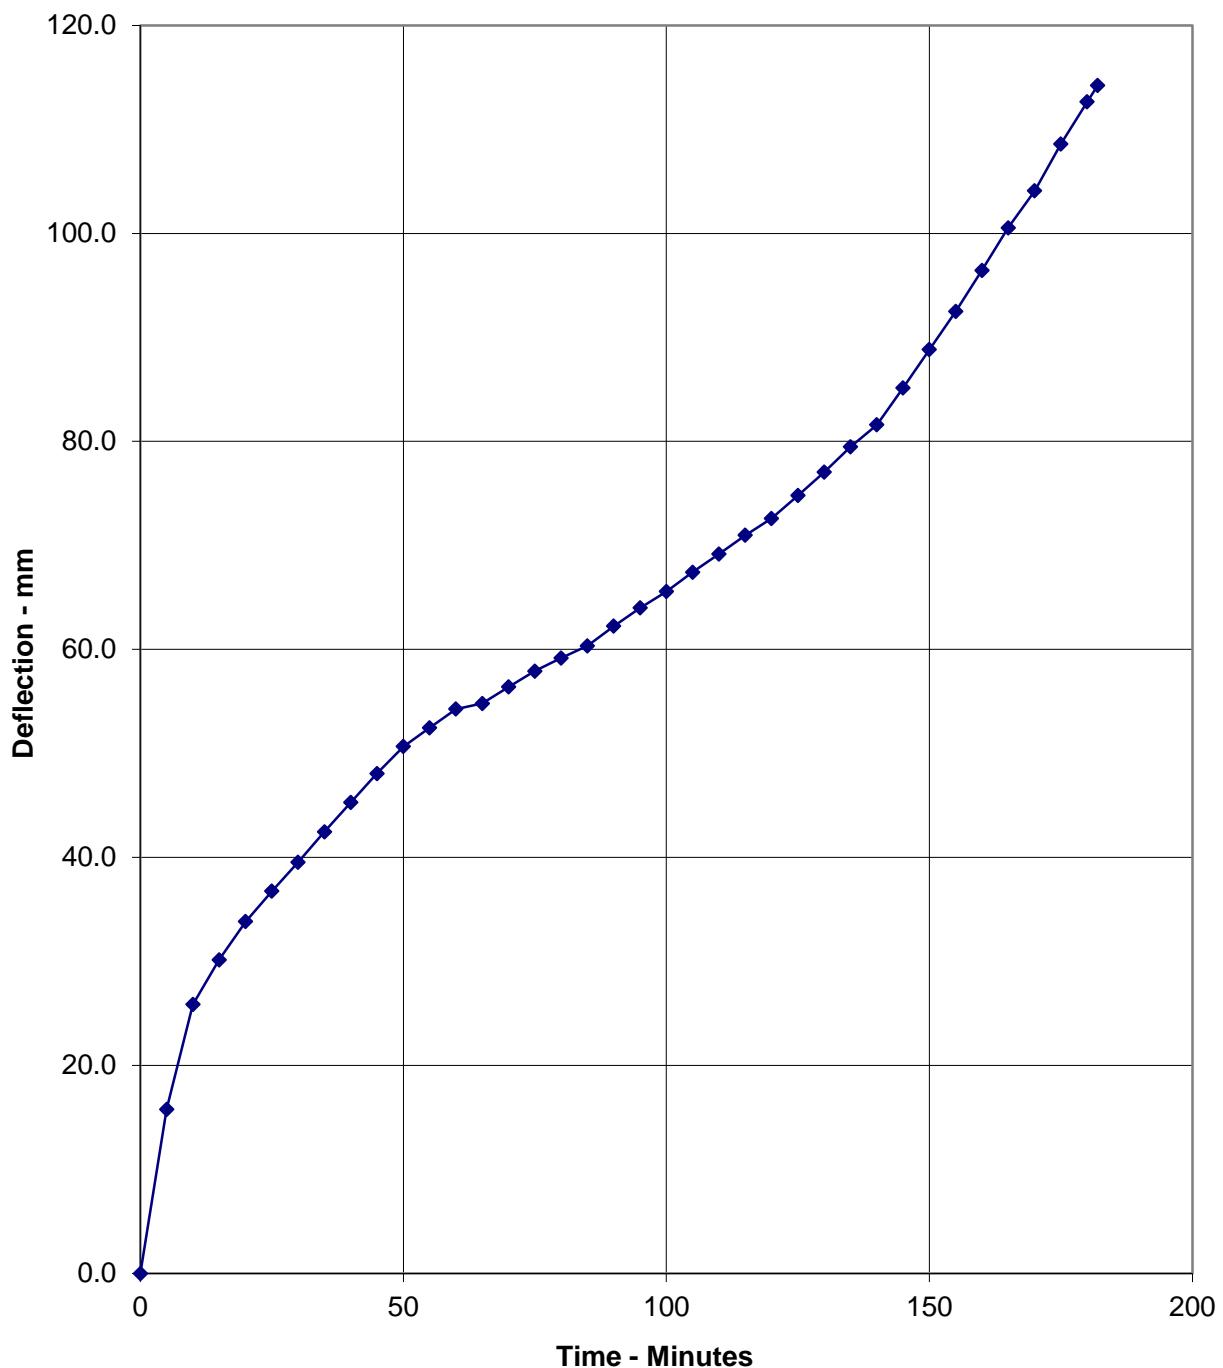
**Graph showing recorded central vertical deflection of the specimen**

Time Minutes	Central Vertical Deflection mm	Rate of Deflection mm/min
0	0.0	0
5	15.8	2.4
10	25.9	1.3
15	30.2	0.9
20	33.8	1.0
25	36.8	0.6
30	39.6	0.5
35	42.5	0.5
40	45.3	0.6
45	48.1	0.5
50	50.7	0.6
55	52.5	0.3
60	54.3	0.2
65	54.8	0.1
70	56.4	0.4
75	57.9	0.3
80	59.2	0.3
85	60.3	0.4
90	62.2	0.5
95	64.0	0.3
100	65.6	0.3
105	67.4	0.5
110	69.2	0.4
115	71.0	0.4
120	72.6	0.2
125	74.8	0.6
130	77.0	0.6
135	79.5	0.7
140	81.6	0.4
145	85.1	0.8
150	88.8	1.0
155	92.5	0.7
160	96.4	0.9
165	100.5	0.7
170	104.1	0.6
175	108.6	0.7
180	112.6	0.6

<b>Structural Adequacy (Loadbearing capacity)</b>	The limiting deflection and the limiting rate of deflection for the specimen, as specified by the Standard, are calculated as 220 mm and 9.8 mm per minute respectively, based on a floor depth of 120 mm (d) and a clear span of 3250 mm (L). The specimen satisfied these criteria for the test duration of 180 minutes.
<b>Integrity</b>	<p>It is required that the specimen retain its separating function, without:</p> <ul style="list-style-type: none"><li>▪ causing ignition of a cotton pad when applied</li><li>▪ permitting the penetration of a gap gauge in the prescribed manner</li><li>▪ sustained flaming on the unexposed surface</li><li>▪ Integrity failure also occurs simultaneously with loadbearing capacity failure.</li></ul> <p>The integrity requirements were satisfied for the test duration of 180 minutes.</p>
<b>Insulation</b>	<p>It is required that the mean temperature rise of the unexposed surface shall not be greater than 140°C and that the maximum temperature rise shall not be greater than 180°C. Insulation failure occurs simultaneously with integrity failure. The insulation requirements were satisfied for the test duration of 180 minutes.</p>
