STRUCTURES TEST REPORT

ST10247-001-01

TESTING OF "TIMBA TIE" PILE/BEARER CONNECTIONS FOR DAVID REID BUILDERS

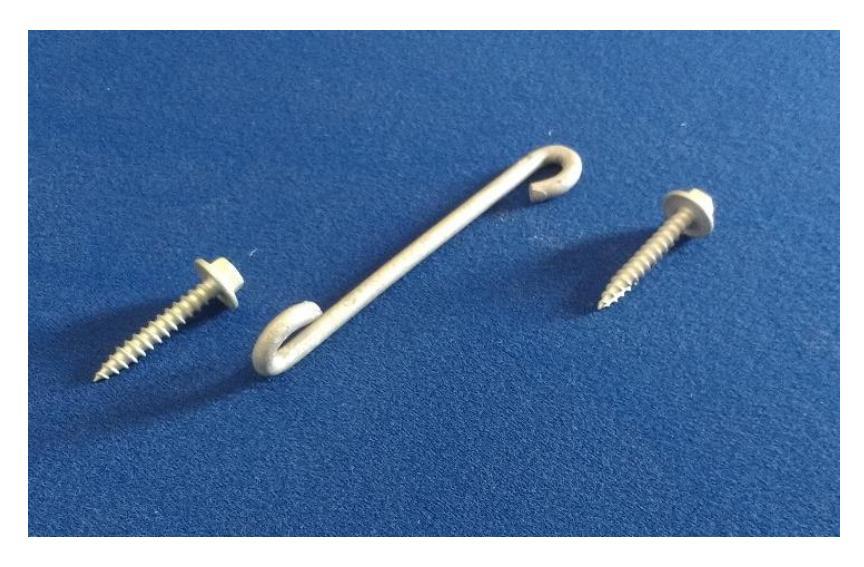
The Timba Tie is a length of galvanised steel wire bent into a double loop arrangement as shown in Photograph 1 and is intended to perform a similar function as a wire dog (or Z nail). The wire measured 4.4 mm diameter (over galvanising), the fastener measured 110 mm long over the loops and was supplied with 2 hex head self drilling wood screws. The screws measured 5.6 mm diameter (outside of threads) and were 35 mm long.

Photograph 1 Timba Tie with screws as received

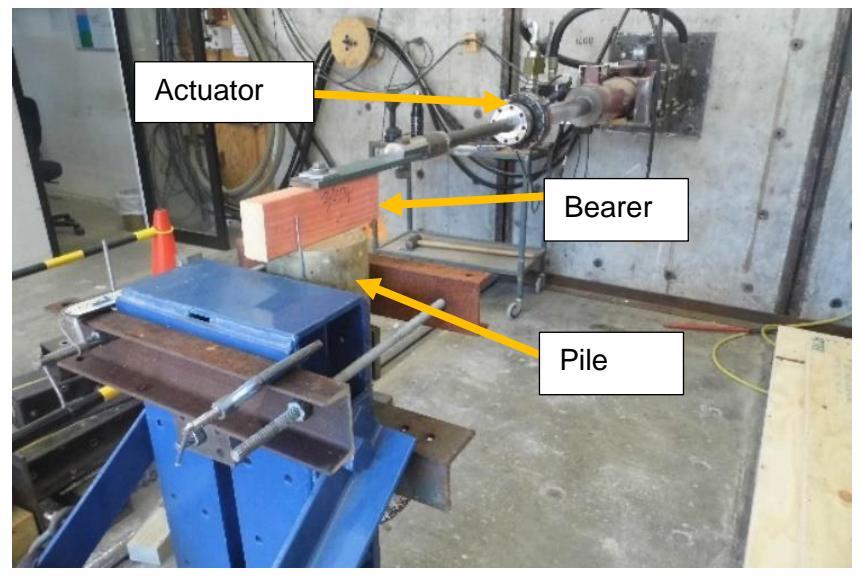
Piles (round and square) were clamped in a vertical orientation to a buttress fixed to the laboratory strong floor (Photograph 2).

Photograph 2. Test set up for pile to bearer connection (parallel to bearer shown)

Short lengths of 90×45 bearer were attached to the top of the pile using either the standard NZS 3604 details (2 skew nails plus 2 wire dogs), or two Timba Tie connectors. The bearers were fixed parallel or perpendicular to the loading direction. These combinations are set out in Table 1.

Load was applied to the bearer by a closed loop servo-hydraulic actuator through a steel link bar fixed to the top of the bearer (shown in Photograph 2). Applied loads were measured using a 25 kN load cell, and a linear potentiometer internal to the actuator was used to measure the horizontal displacement of the bearer.

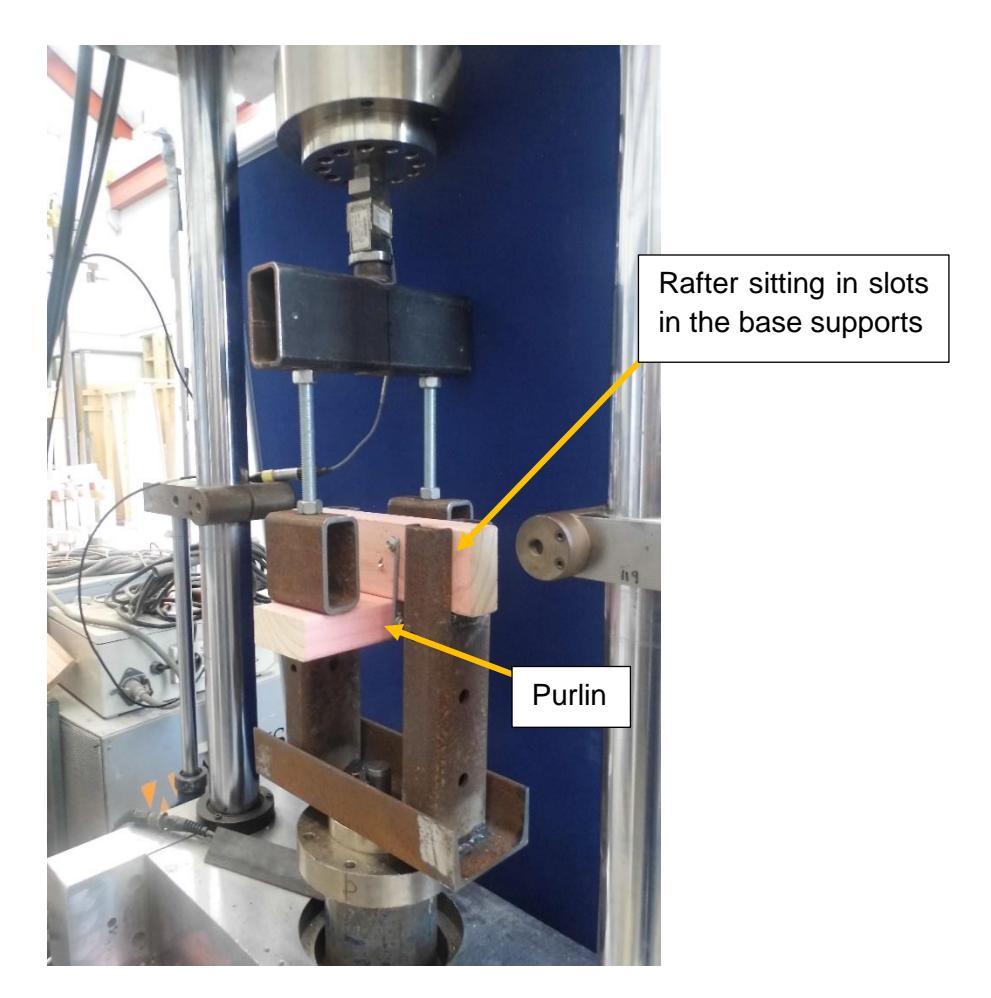
The purlin to rafter specimens were tested in a Dartec Universal Testing Machine by supporting the rafter on the base of the machine, with a load bridge attached to the machine crosshead to push the purlin off the rafter. A view of the set up may be seen in Photograph 3. Applied loads were measured using a 10 kN load cell. A linear potentiometer reading the machine crosshead movement was used to measure the vertical displacement of the purlin. The potential eccentricity of some of the specimens required additional support to keep the members in correct alignment as they would be in a normal roof situation where support is provided by roofing and other framing. This was achieved by cutting slots in the base supports, as can be seen in Photograph 5.

Photograph 3. Test set up for purlin to rafter connection

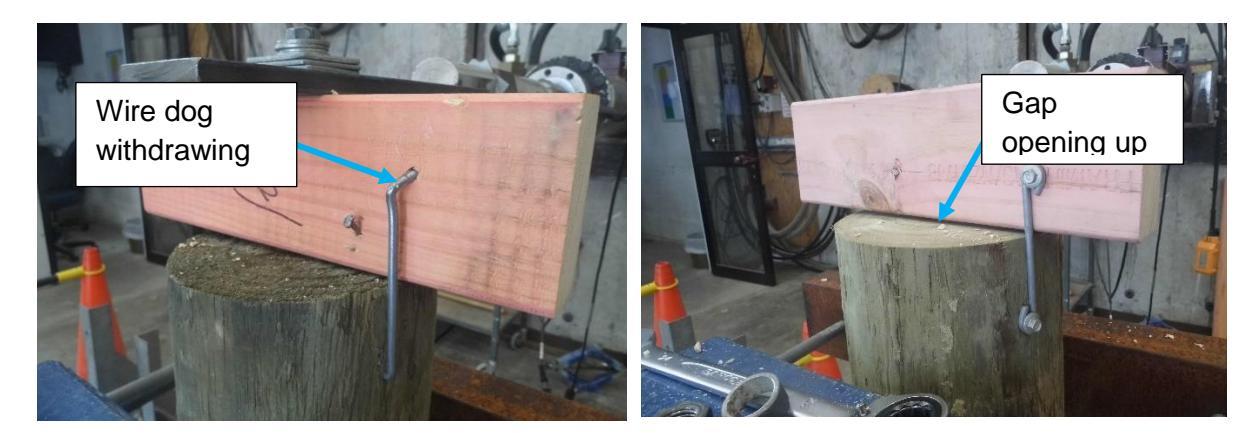
Both the wire dog and the Timba Tie bent to accommodate the reversing displacement, and at the end of the test the wire dog and skew nail in the 3604 detail worked their way partly out of the timber (Photograph 4). The Timba Tie connection also lifted off the pile somewhat (Photograph 4 right) although no specimens became detached over the full duration of the testing.

Photograph 4. Pile to bearer connectors during shear testing. Left: Z nail withdrawing from bearer. Right: Bearer separating from pile during the Timba Tie testing.

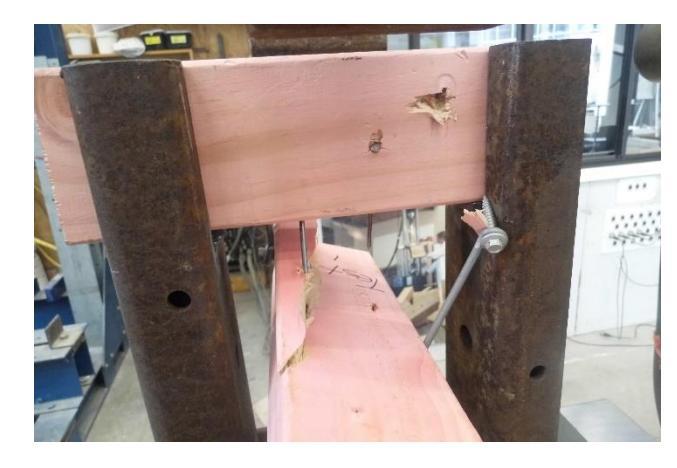
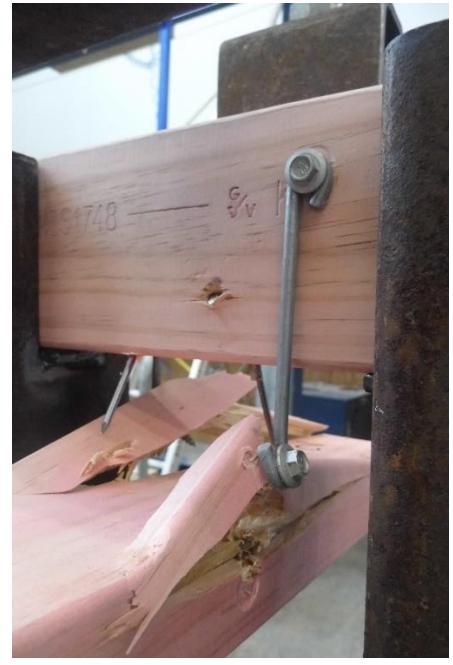
For the purlin to rafter configuration, the screws withdrew from the timber and the joint pulled apart with some specimens suffering severe splitting of the timber (see Photograph 5).

Photograph 5. Purlin to rafter connection under a pull-off test.

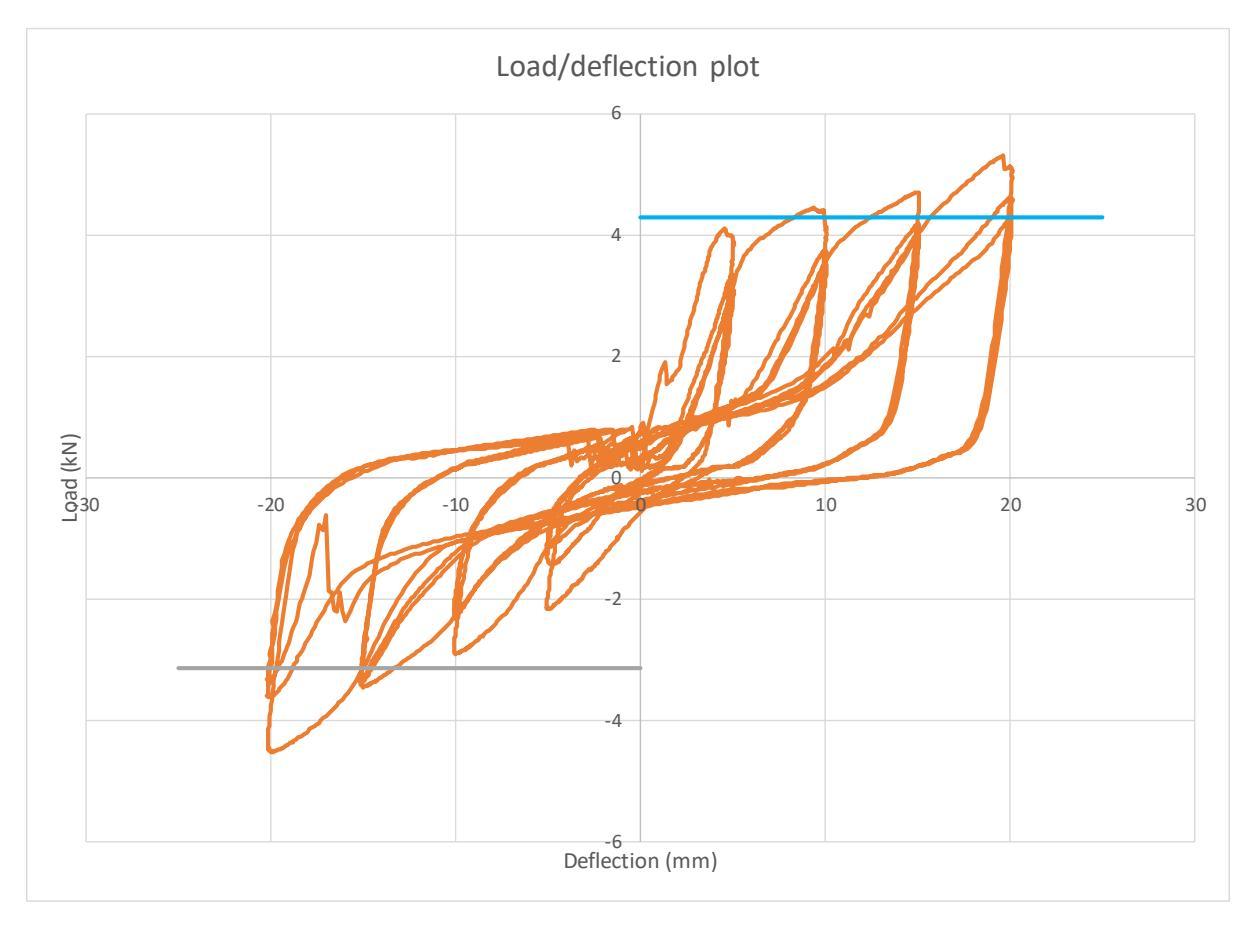
A representative plot of load against deflection for the pile to bearer tests is shown in Figure 1.

Figure 1. Representative load/deflection plot for pile to bearer test

The peak loads resisted during the third deflection cycle of each specimen (shown as the horizontal blue and grey lines in the plot) were extracted from the measurements, and the positive and negative values averaged. The averages for each specimen were tabulated, and the sample standard deviation calculated for the five results to get a measure of the variability of the joint. The results for each configuration are presented in Table 2. For most configurations, the Timba Tie mean values were slightly higher than the Z nail values, but the differences are not significant, considering the small size of the sample.

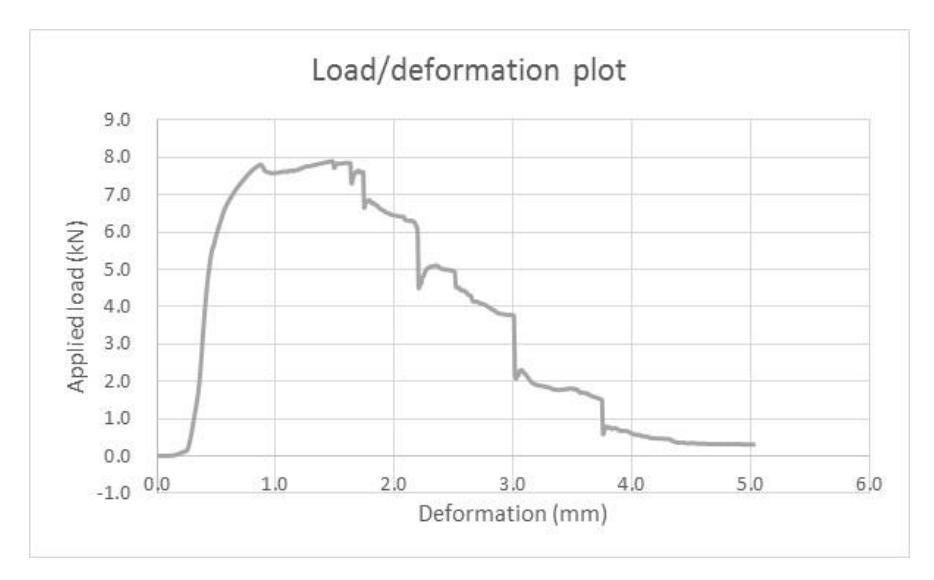
A representative plot of load against deformation for the purlin to rafter tests is shown in Figure 2.

Figure 2. Typical load/deformation plot for purlin to rafter connection tests
